Parcel C (RU-C2) Remedial Action (Excavation and SVE) Project Update

**Hunters Point Naval Shipyard
BCT Meeting August 7, 2014**

Tony Konzen, P.G., Project Manager
Contracted Support for Navy BRAC
Hunters Point Naval Shipyard

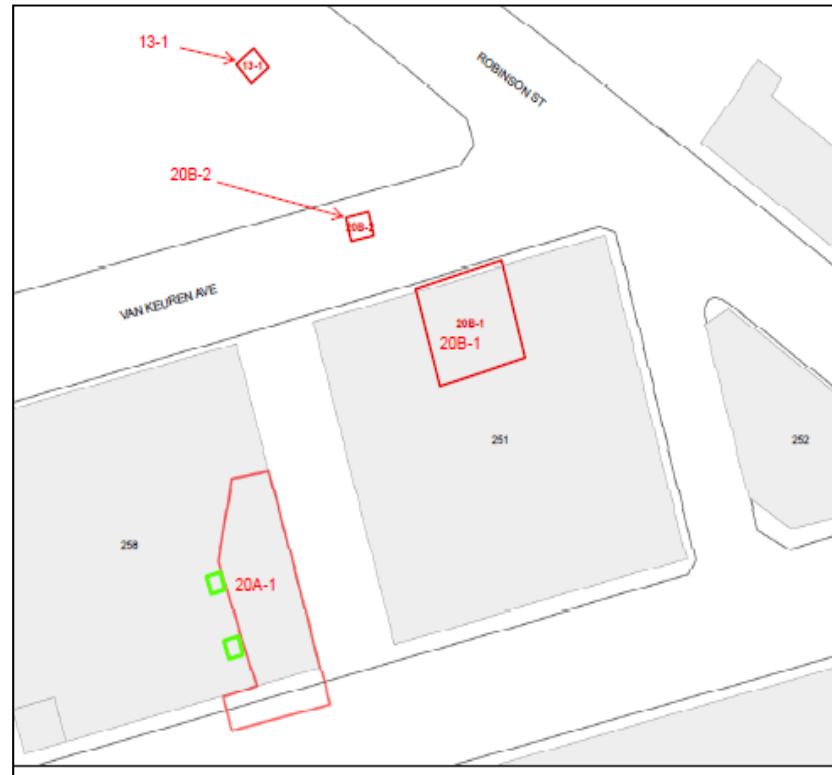
Overview of Excavation 13-1 and 20B-2

- Depth: 10 ft bgs
- Area: 15 ft x 15 ft
- Volume: ~ 90 cubic yards
- COCs: SVOCs (except PAHs) and Pesticides
- All results below Residential RGs.

- Depth: 10 ft bgs
- Area: 15 ft x 15 ft
- Volume: ~ 90 cubic yards
- COCs: PAHs.
- All results below Residential RGs.

Note: For both excavations, sidewall samples collected at a rate of one per 20 linear feet, and 5 feet of vertical wall sidewall. Floor samples were collected at a rate of one per 500 square feet.

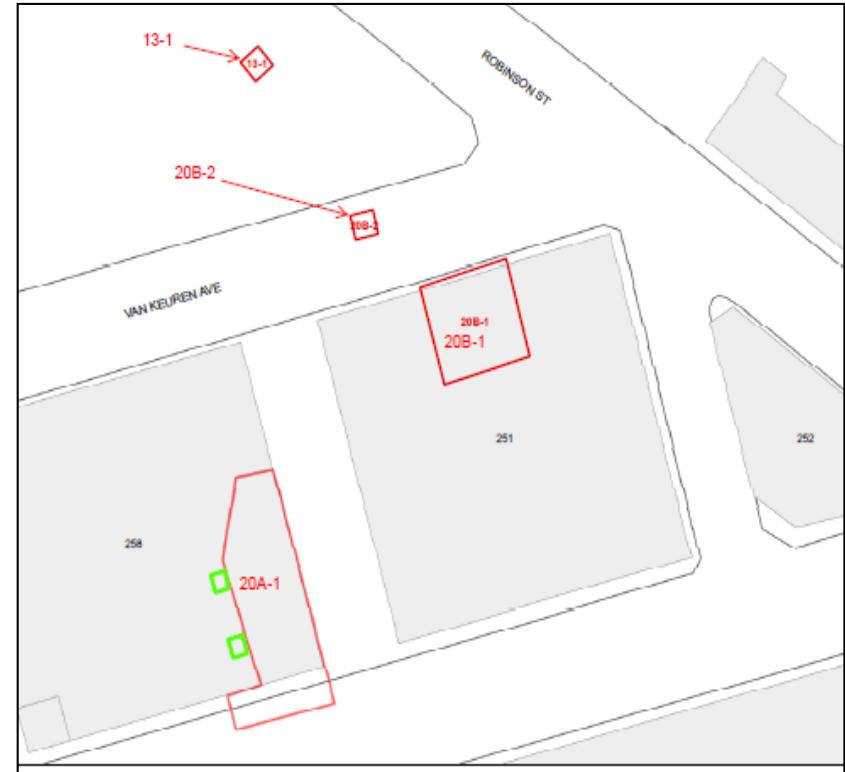
Overview of Excavation 20B-1

- Depth: 10 ft bgs
- Area: 60 ft x 60 ft (extent of previously excavated concrete foundation area)
- Volume: ~ 1,300 cubic yards
- COCs: VOCs (except benzene), PCBs (Aroclor 1254 and 1260), PAHs, TPH, and metals.
- Residential RGs not met; additional excavation required.

Note: side wall samples collected at a rate of one per 20 linear feet, and 5 feet of vertical wall sidewall.
Floor samples were collected at a rate of one per 500 square feet.

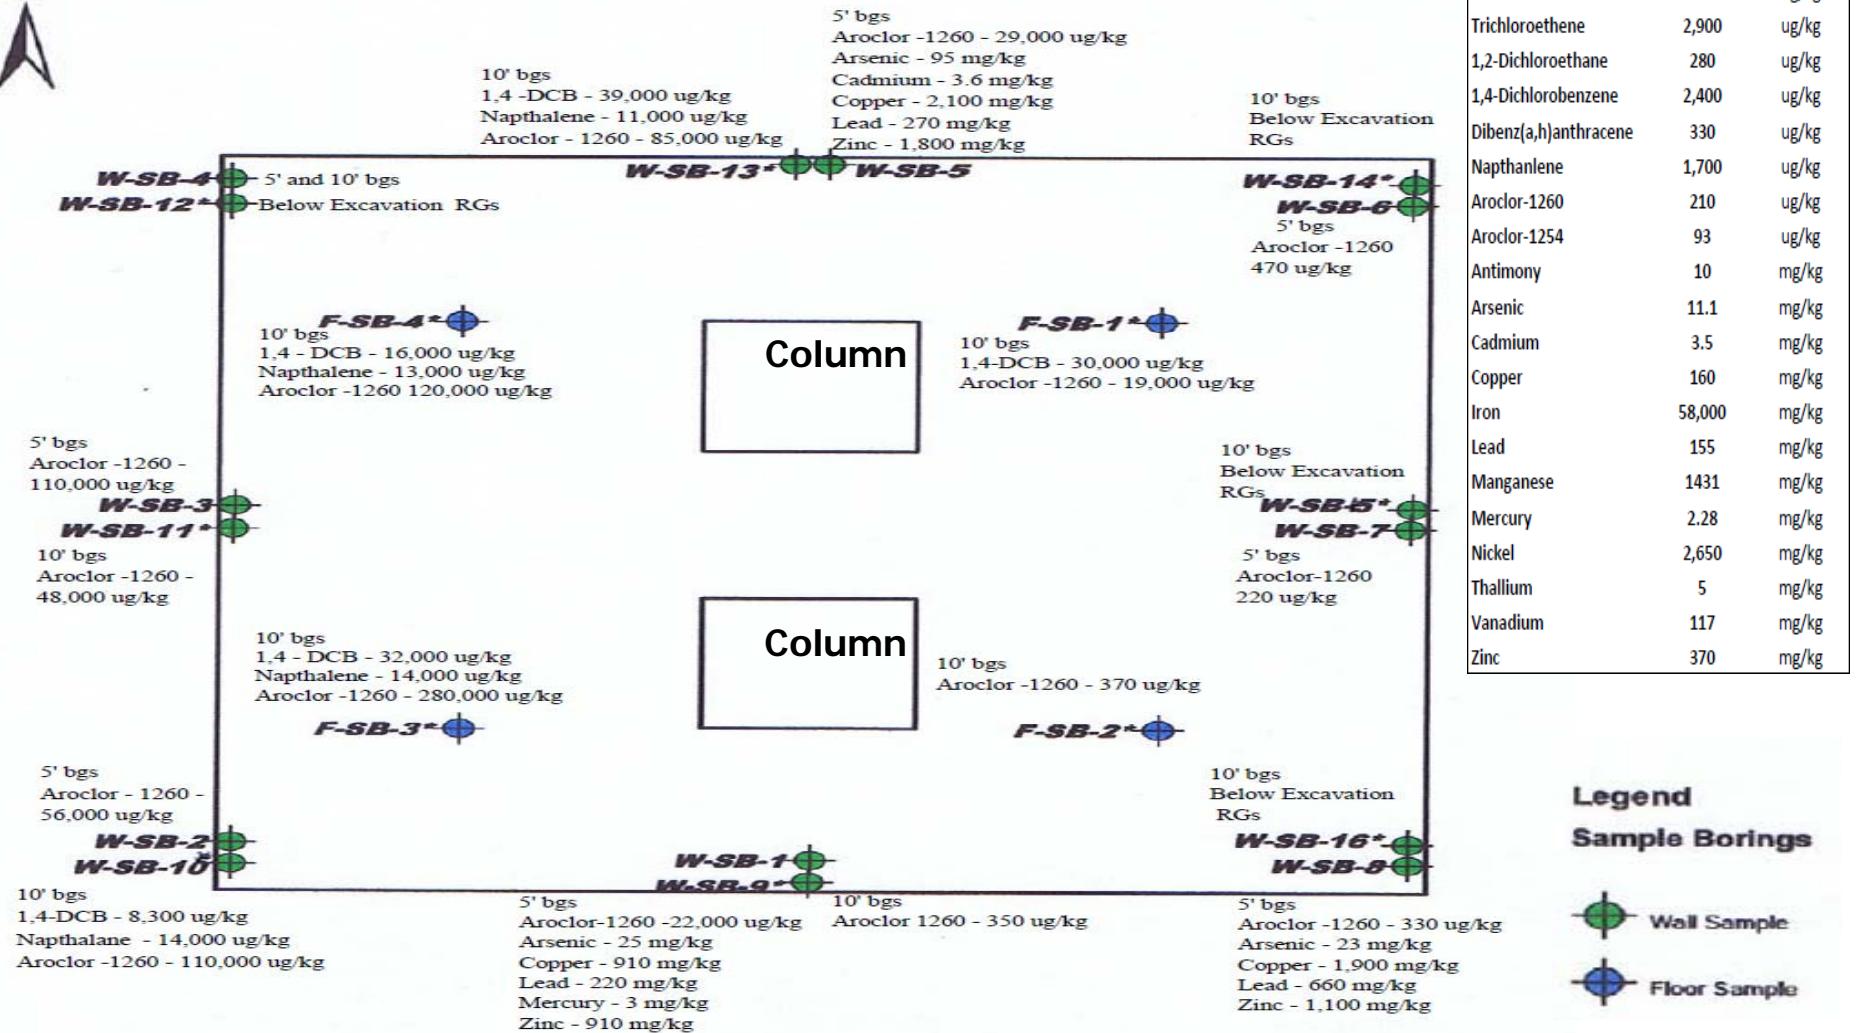
Excavation 20B-1 Sample Locations and Results

- Excavated to 10 feet bgs in the area where the foundation was previously removed.
- Elevated concentrations of PCBs, 1,4-DCB, naphthalene, and metals remain in the sidewalls. Elevated PCBs, naphthalene, and 1,4-DCB remain in the excavation bottom at 10 feet bgs (the maximum depth of remediation prescribed by the ROD).
- Additional investigation and remediation is planned to laterally and vertically define and remove elevated COCs to the extent practicable in early FY15.

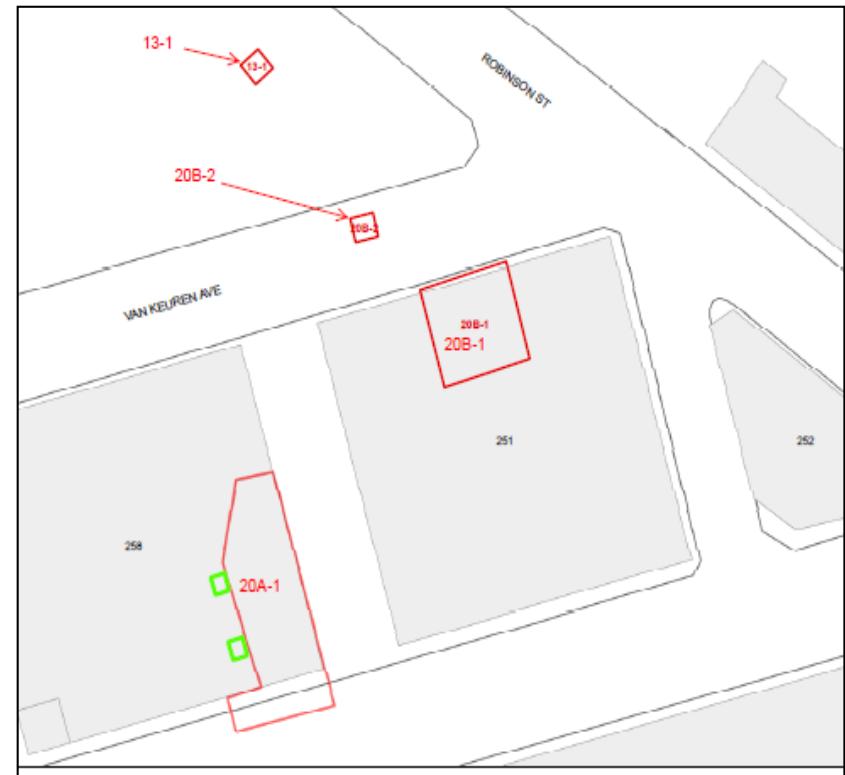
Overview of Excavation 20A-1

- Depth: 10 ft bgs or bedrock
- Area: 125 ft x 50 ft
- Volume: ~ 2,500 cubic yards
- COCs: VOCs (except benzene), PAHs, PCBs (Aroclor 1254 and 1260), and metals.
- Residential RGs met or bedrock/utility corridors encountered.

Note: sidewall samples collected at a rate of one per 20 linear feet, and 5 feet of vertical wall sidewall.
Floor samples were collected at a rate of one per 500 square feet.

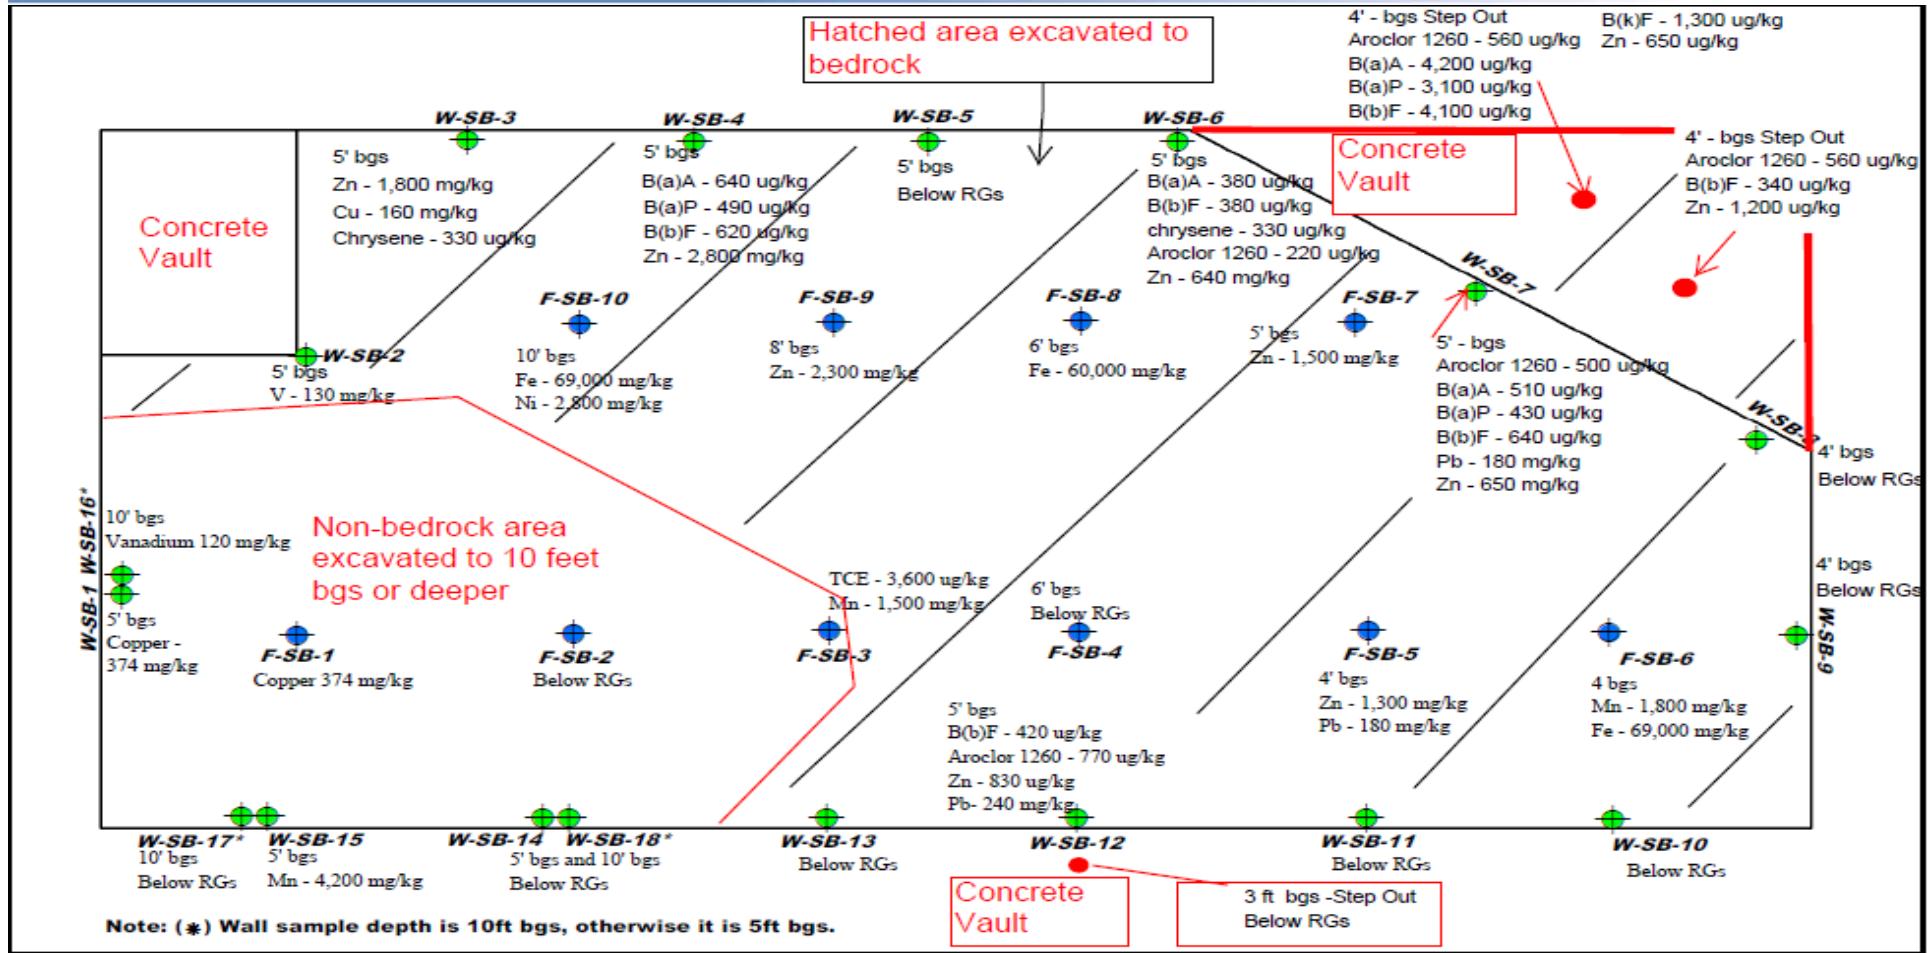
Excavation 20A-1 Sample Locations and Results

- PAHs, Aroclor-1260, Zn, and Pb above RGs still exist at the sidewalls in the NW corner of excavation 20A-1 (see W-SB-7). This area is at bedrock and up against the building foundation.
- PAHs, Aroclor 1260, zinc and copper above RGs exist on the west wall of the excavation, but are underneath the foundation of the building at 5 feet bgs.
- Metals (Fe, Pb, Ni, Mn and Zn) above RGs remain in floor samples collected at bedrock (4 – 10 feet bgs).

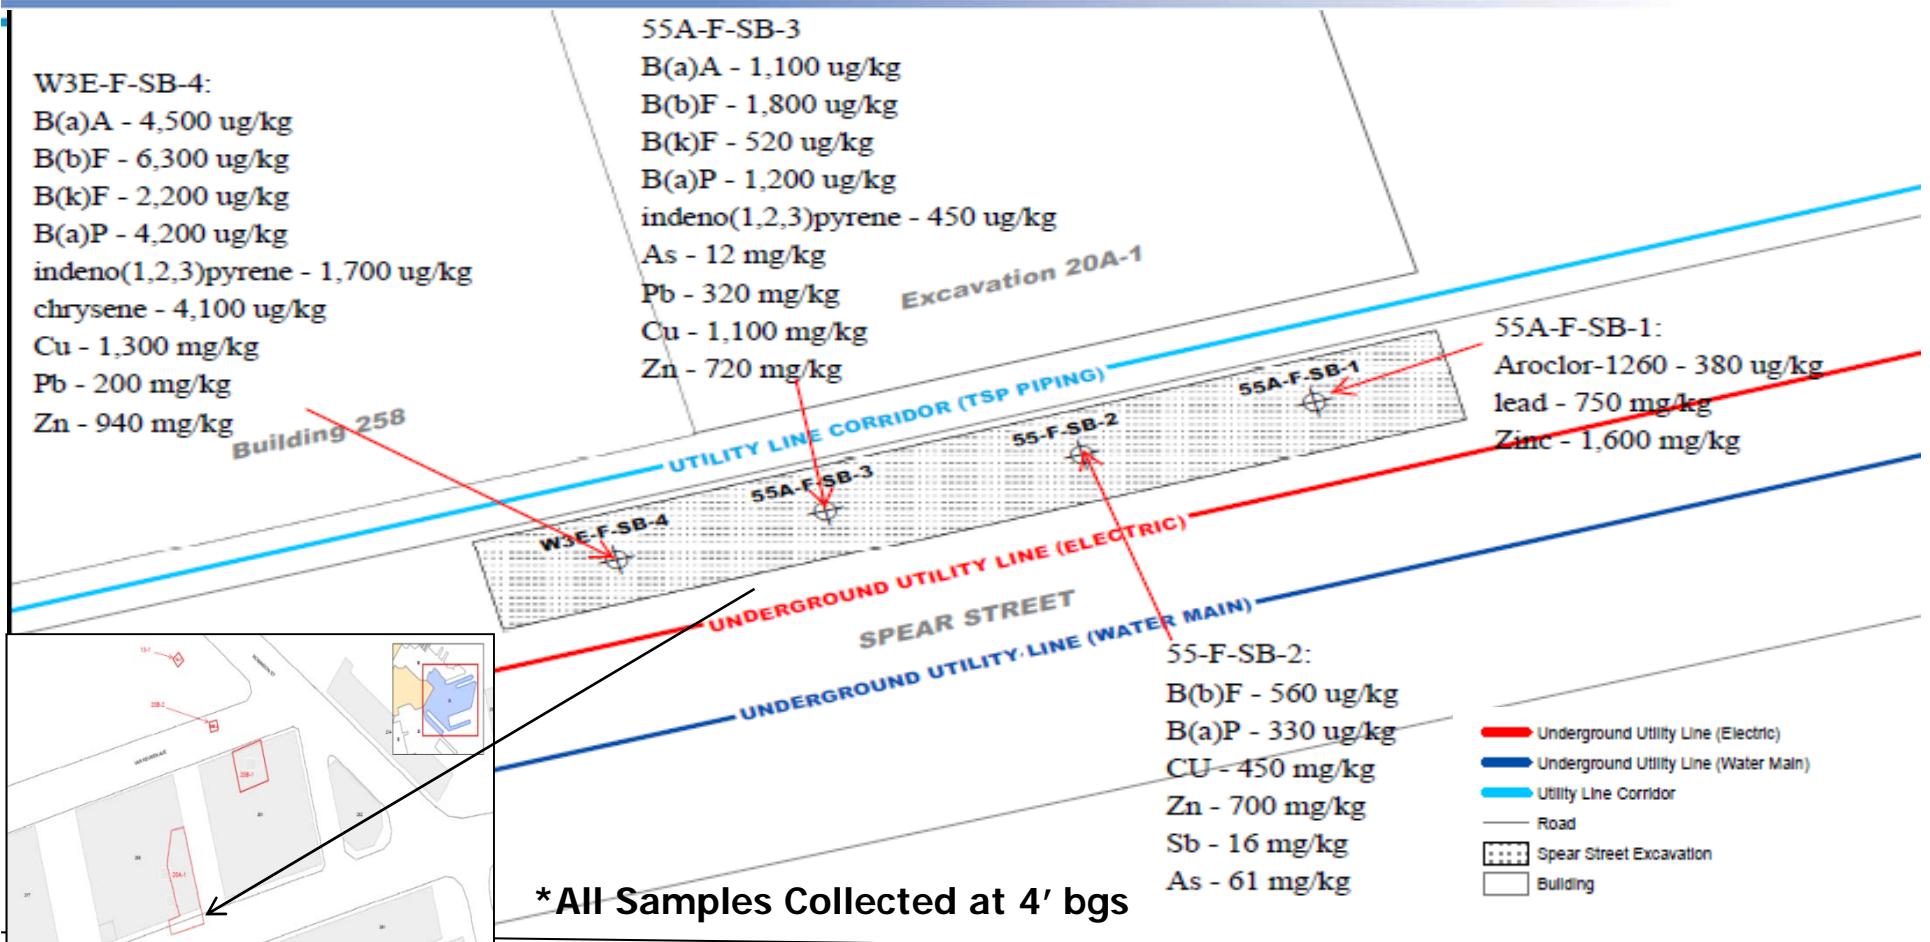
Excavation 20A-1 at Spear Ave – Sample Locations and Results

- PAHs above RGs exist at 4 feet bgs in a utility corridor (fiber optic, water, electric, and ACM wrapped piping) that could not be excavated to 10 ft bgs.

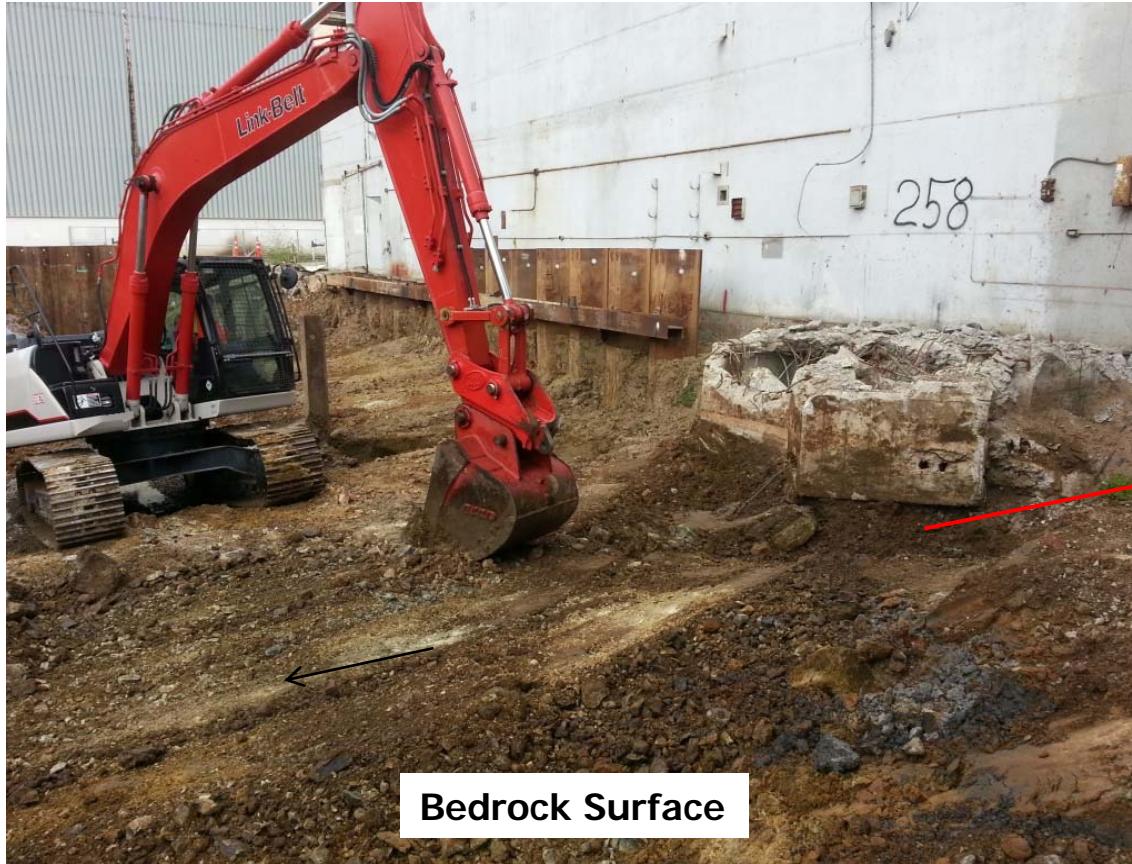
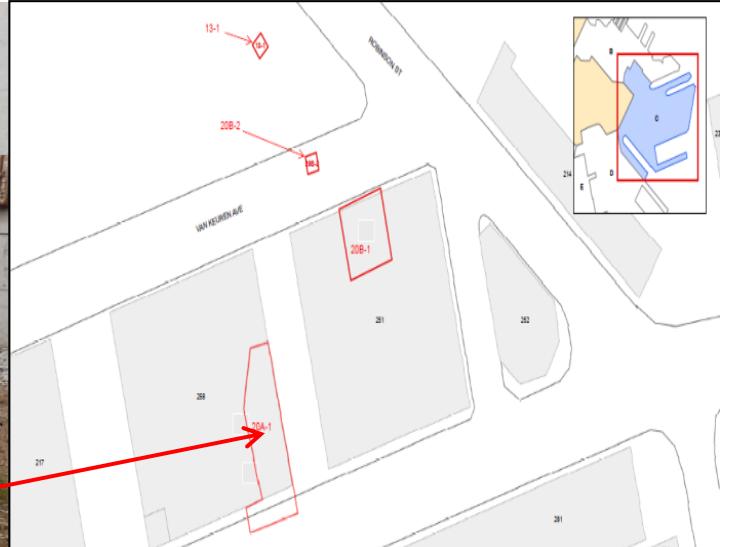
Excavation 20A-1 at Building 258

- Step-out Excavation at 20A-1, bedrock slopes down to the south.

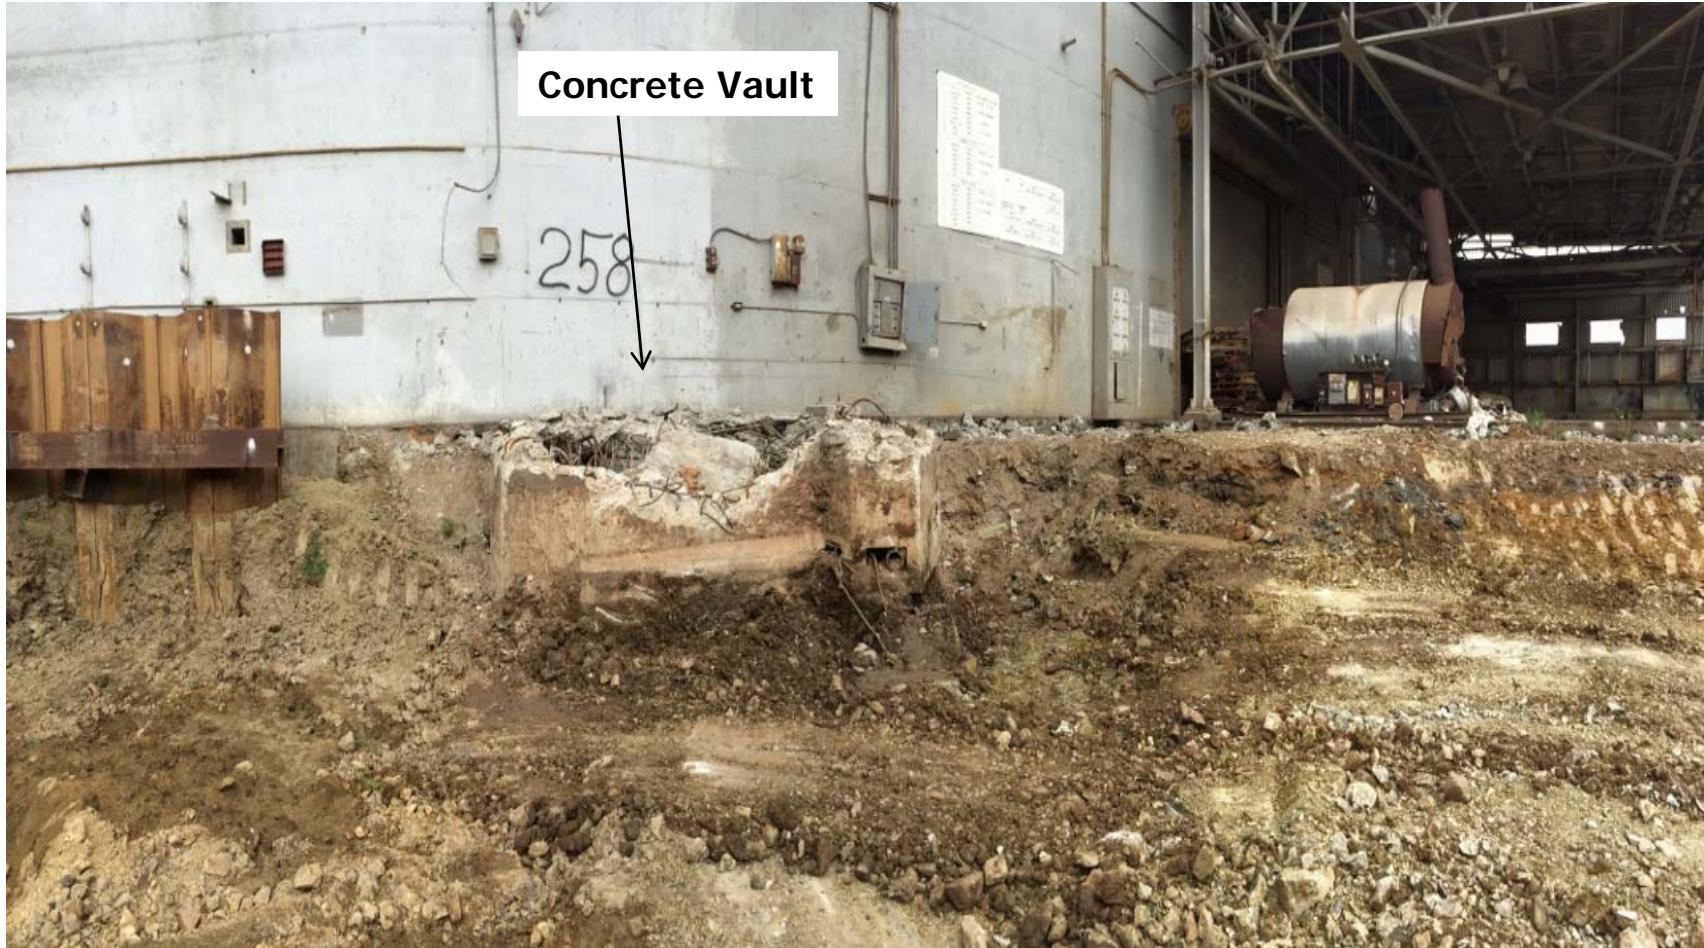
Excavation 20A-1 at Building 258

One of the concrete vaults in excavation 20A-1 that is connected to the building foundation. The vault is hollow with utility piping and extends down into bedrock.

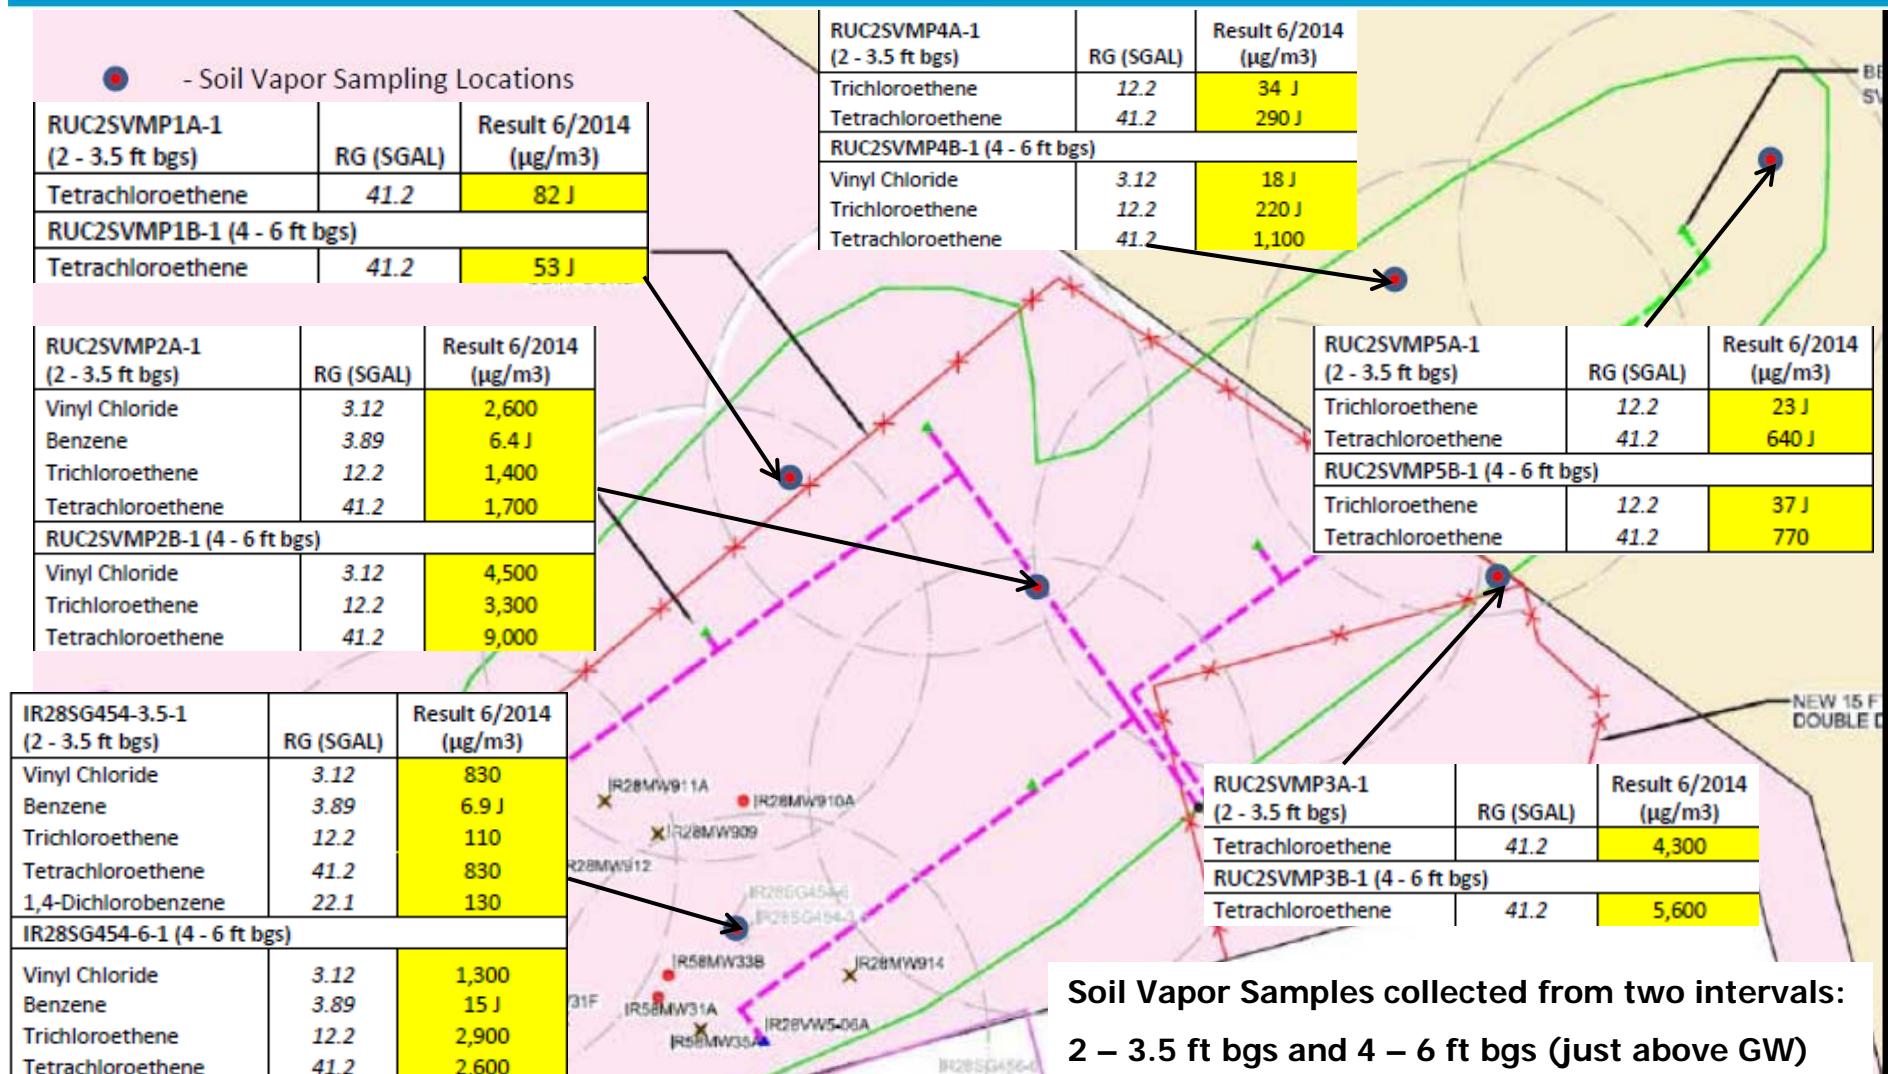
Current Soil Vapor Conditions – June 2014

- Baseline soil gas samples were collected from soil vapor monitoring point locations in June 2014.
- COCs for SVE-1 Area are based on the latest SGALS.
- Soil vapor concentrations in soil gas above RGs consist mainly of PCE, TCE, and daughter products (results presented on next slide).

- The infrastructure (compound, concrete pad, piping) for the SVE-1 Area will be installed by Alliance Comp JV in the footprint of the area defined in the Parcel C ROD and RU-C2 RAWP.
- A SVE system at RU-C1, RU-C4 or RU-C5 will be installed at RU-C2 SVE-1 Area once inlet VOC concentrations are asymptotic and/or remediation is complete at one of the aforementioned remedial units. The Parcel C SVE O&M Manual will be updated at that time to reflect this planned approach.
- The RU-C2 SVE-1 Area system will be operated using the same procedures outlined in the O&M Manual (Soil Vapor Extraction System Operation and Maintenance Plan, CB&I 2014).
